#### 第 57/2015 號行政長官公告

國際海事組織海上安全委員會於二零零二年五月二十四日透過第MSC.125(75)號決議通過了《散貨船和油輪檢驗期間的強化檢查方案指南》(經修正的第A.744(18)號決議)的修正案，該修正案自二零零四年一月一日起適用於澳門特別行政區；

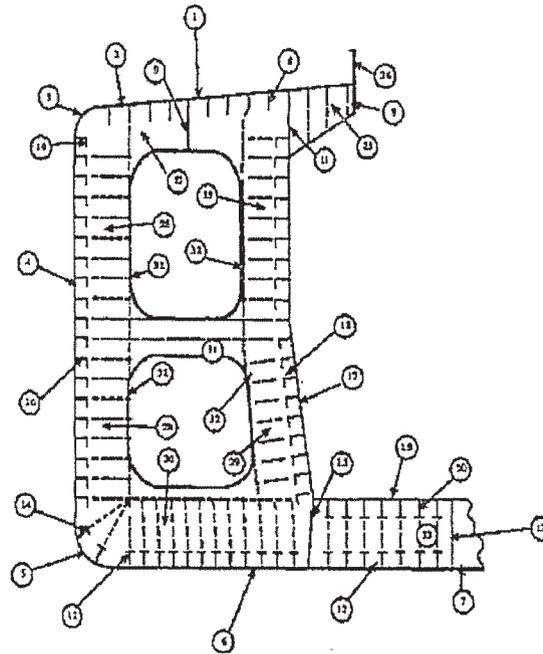
厚度測量和表明縱向和橫向構件的典型橫截面

<p>TM2-BC (1) 和 (2) 上的報告</p>	<p>TM3-BC 上的報告</p>	<p>TM4-BC 上的報告</p>
<p>1. 強力甲板板材 2. 縱桁板 3. 船側厚板 4. 船側殼板 5. 舳板 6. 船底外殼板材 7. 龍骨板</p>	<p>8. 甲板縱材 9. 甲板桁材 10. 船側厚板縱材 11. 縱向艙壁頂部列板 12. 艙底縱材 13. 船底桁材 14. 舳部縱材 15. 縱向艙壁下列板 16. 舷側外殼縱材 17. 縱向艙壁板材(剩餘) 18. 縱向艙壁縱材 19. 內底板材 20. 內底縱材</p>	<p>25. 甲板橫向中央液艙 26. 底部橫向中央液艙 27. 甲板橫向翼液艙 28. 舷側外殼垂直桁材 29. 縱向艙壁垂直桁材 30. 底部橫向翼液艙 31. 支柱 32. 橫向桁材面板 33. 雙層底肋板</p>
<p>TM6-BC 上的報告</p> <p>36. 艙口圍板 37. 艙口間甲板材 38. 艙口蓋</p>

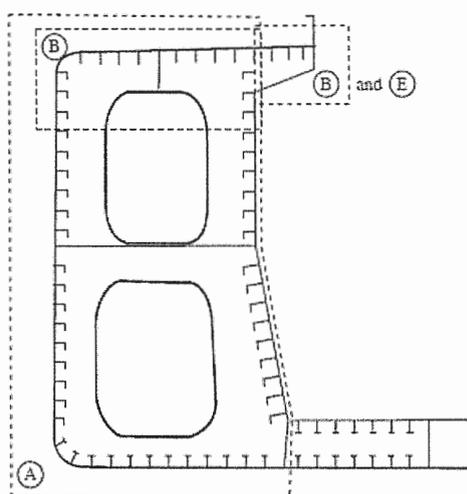
典型橫截面細節檢驗

視情在附件 B 的 TM3-T 和  
附件 B 的 TM4-T 上報告的厚度

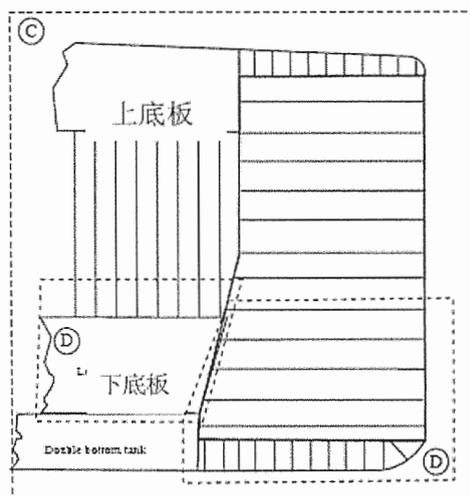
典型橫向艙壁

在附件 B 的 TM5-T 上報告的厚度  
關於測量範圍和方式的建議案列在附件  
10 中

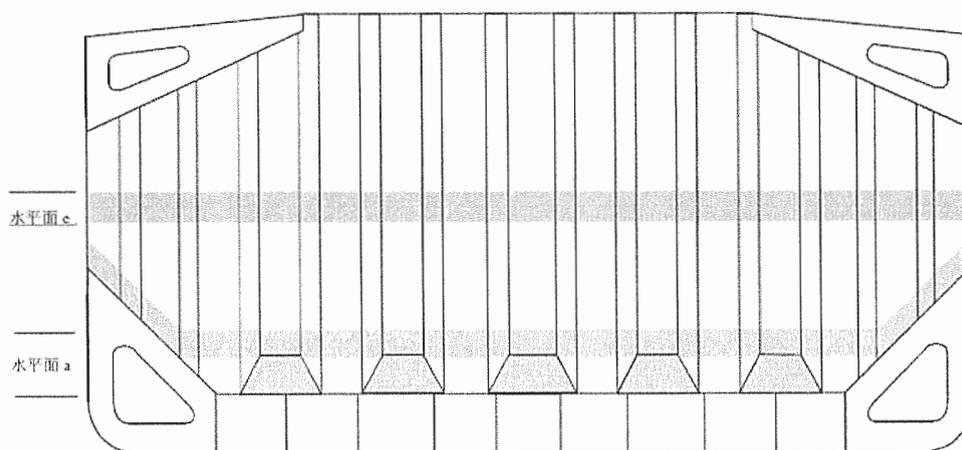
圖例 1：不帶下底板的船舶

4 如果橫向水平面的厚度有變化，則應對較薄的底板予以測量。

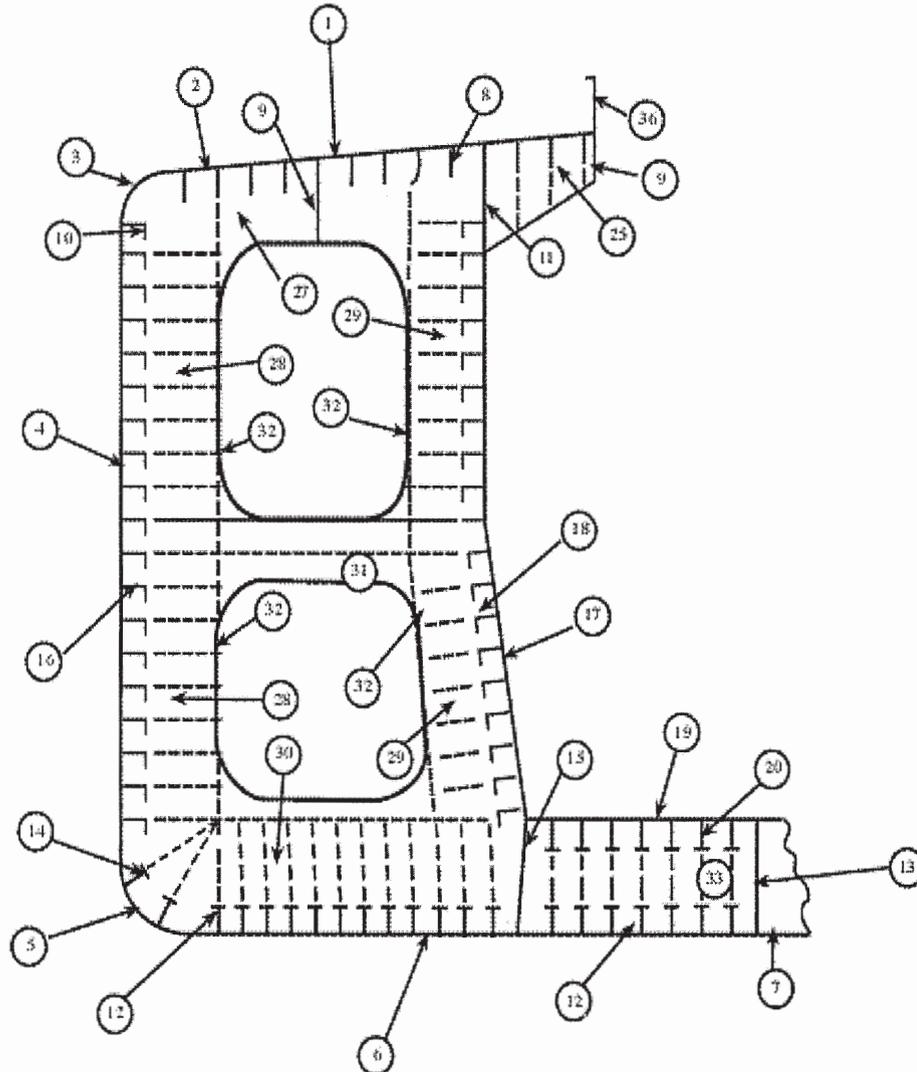
Thickness measurement and typical transverse section indicating longitudinal and transverse members

Report on TM2-BC (1) and (2)	
1.	Strength deck plating
2.	Stringer plate
3.	Sheerstrake
4.	Side shell plating
5.	Bilge plating
6.	Bottom shell plating
7.	Keel plate

Report on TM6-BC	
36.	Hatch coamings
37.	Deck plating between hatches
38.	Hatch covers

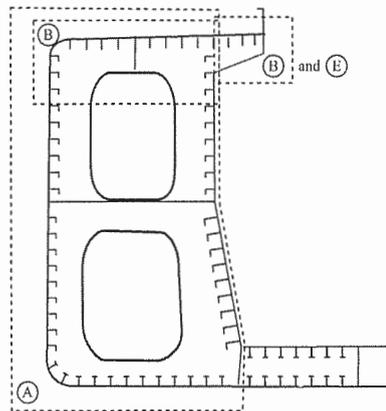
Typical transverse section close-up survey

Thickness to be reported on  
TM3-T of Annex B and TM4-T of Annex B  
as appropriate

Close-up survey  
area

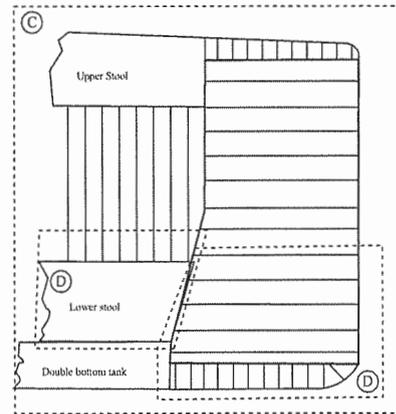
Typical transverse bulkhead

Thickness to be reported on TM5-T of Annex B

Recommendations for the extent and pattern of gaugings  
are indicated in Annex 10.

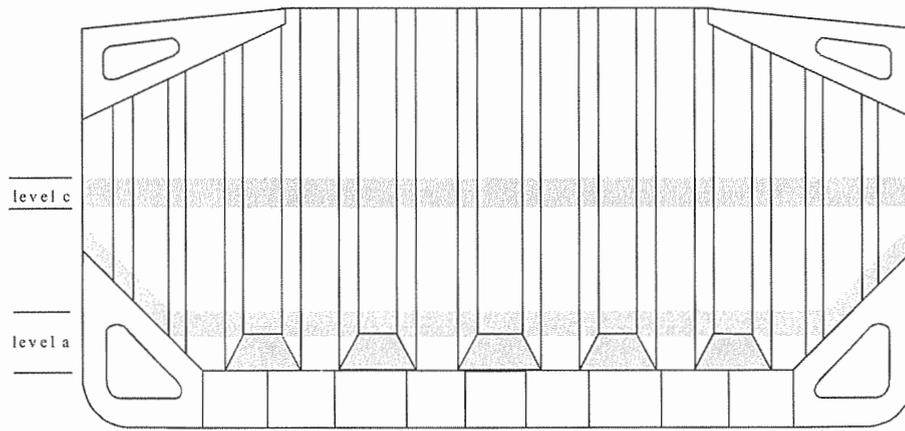
Figure 1. Ships without lower stool

4 Where the thickness changes within the horizontal levels, the thinner plate should be gauged.

2 Taking into account the buckling model specified in the Bulk carrier bulkhead and double bottom strength standards, defined in regulation XII/1.5 of the Convention, in the evaluation of strength of the bulkhead, it is essential to determine the thickness diminution at the critical levels shown in figures 1 and 2 of this annex.

Level (a) Ships without lower stool (see figure 1):

Level (c) Ships with or without lower stool (see figures 1 and 2):
